March 11, 2020  
 Tree Assessment Report  
 706 South Main Street, Hailey

Alpine Tree Service has been asked by ARCH Community Housing Trust to assess the condition of the trees on a parcel of property located at 706 South Main Street in Hailey. The site was formerly occupied by a hospital and senior care facility. The site is vacant with the exception of a number of trees. The purpose of this report is to evaluate those trees subject to a redevelopment proposal by ARCH.

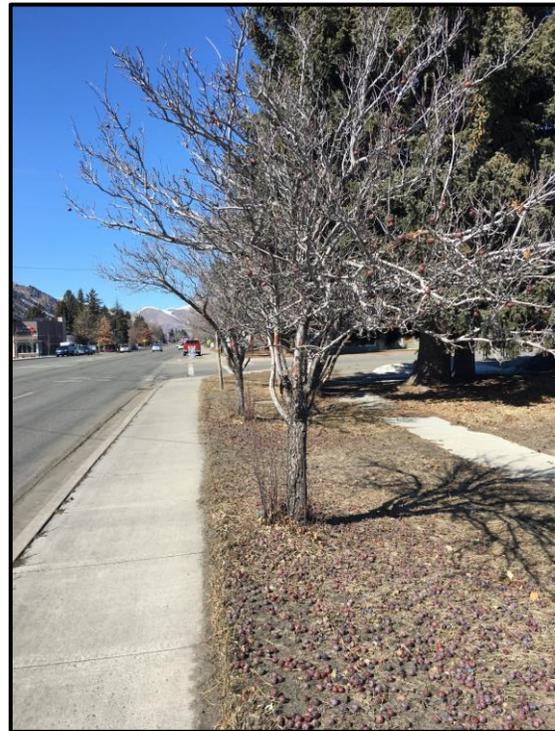
The Bechtel Crabapple trees in the right of way (and pictured at right) are generally in fair condition but should not be considered a significant resource. While the trees do provide some buffer between the property and Main Street, and are attractive when they bloom, the trees were planted more than 25 years ago and have not developed as would be expected. Additionally, the canopy of the trees are too low for suitable use as street trees. Perhaps most significantly, the trees develop and drop a significant amount of fruit, which can be a hazard to pedestrians, and is, at a minimum, a nuisance.

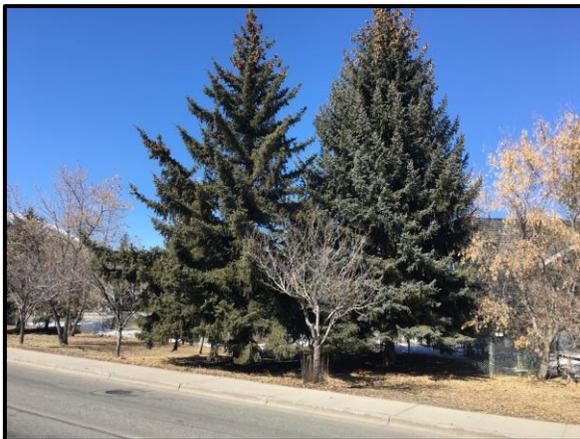
Trees #1, #2 and #3 are all large Colorado Spruce on the southeast corner of the property (shown below). The trees are each approximately 24” DBH (diameter at breast height) and have good structure and crown development. All of the spruce trees on the property show signs of moderate insect infestation, most notably from Pine Needle Scale and Spruce Spider Mites, but none of the insect issues rise to the level where treatment is needed. The trees show good new growth and good health. The trees provide a sound screen between the south side of the property and the adjacent skate park and highway, both of which can be noise concerns. Additionally, the trees provide a good sound barrier between the property and the airport. The trees should be considered a resource and retention of the trees should be strongly considered.

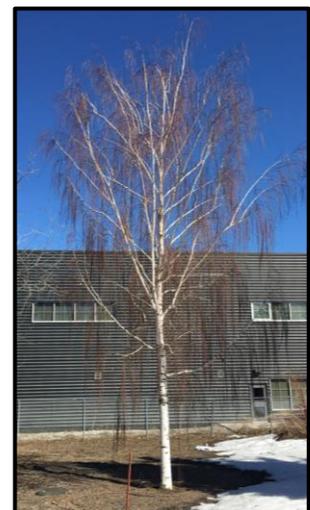
Tree #7 is a Cutleaf Weeping White Birch (*Betula pendula*) (right) in good condition. The tree is somewhat unusual in that it does not appear to have been aggressively attacked by Bronze Birch Borer, which has devastated white birch trees in the Valley. Nonetheless, the tree should not be considered to be of high value, and, should the owners decide to keep it, the tree could be transplanted to another location on the property.

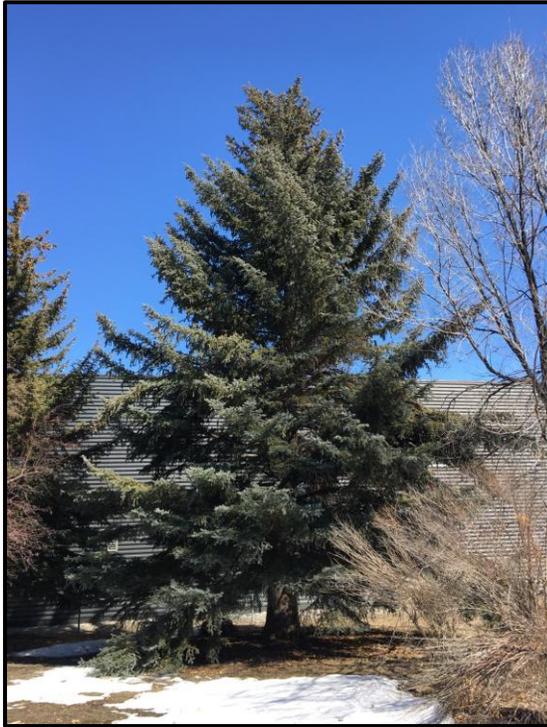
Tree #9 is a 30” Colorado Spruce (left) and one of the nicest trees on the property. The tree has suffered some broken limbs from snow load, but has otherwise sound structure and good health. The tree provides good boundary screening between the blank back wall of the ice house and the property, and should definitely be viewed as an asset.

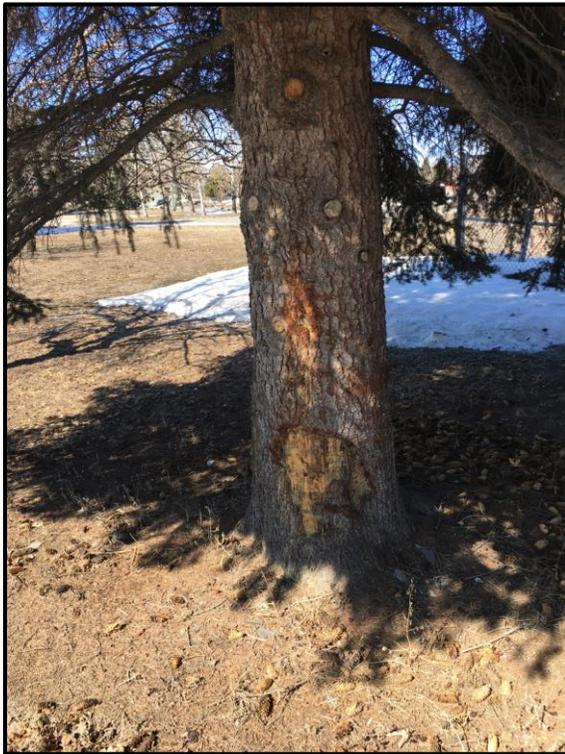
Tree #20 is a 24" Colorado Spruce (left) with good structure and health. The tree has suffered some damage from an auto accident, but the tree is healing well and its overall condition does not appear to have been adversely affected. The tree is a resource and the plan shows that the tree is to be retained. Efforts should be made to safeguard the tree during construction. Recommendations for protection can be provided if needed.

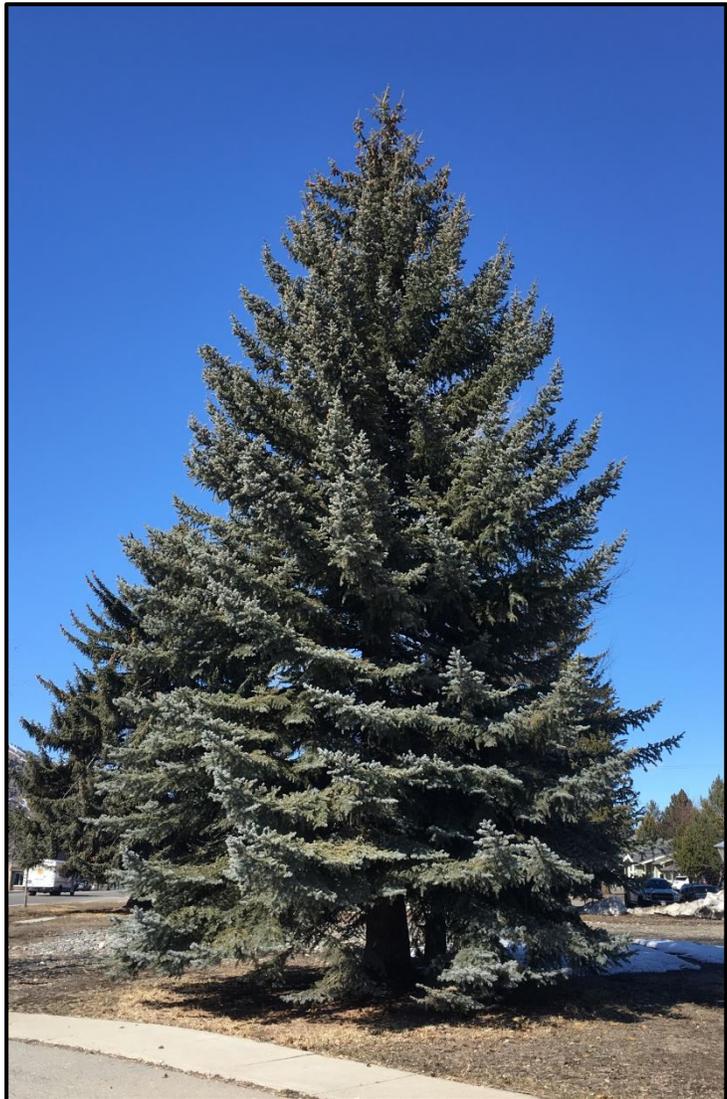
Tree #41, on the other hand, is a 28” Colorado Spruce that is an exemplar of the species (shown at right). The tree has full crown development, robust health, and excellent structure. This tree is unquestionably a resource to the property and its retention should be strongly considered.

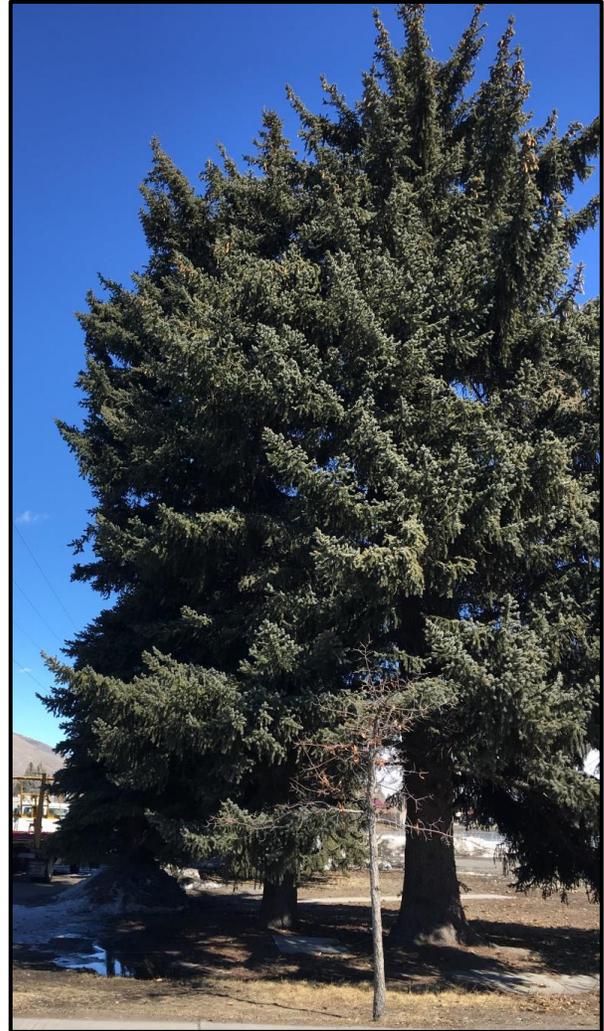
Tree #43, a Colorado Spruce, which, at more than 36" DBH, may be one of the largest spruce trees in Hailey. The tree has good health and fair structure. It has grown in close proximity to Tree #44, a 28" spruce, and the crowns of both trees are affected by their proximity. The two trees are shown at right. The trees are relatively close to power transmission lines on the north side of the trees, but, to date, no significant pruning appears to have taken place to clear the power lines. The trees are an issue for Maple Street, in that conifers of this size can cause ice buildup due to shade on the street. They are, however, an asset to the property in terms of boundary, screening, and wind protection. Winter winds out of the north, most notably at night, are significantly slowed by conifers on the north side of residences, thereby significantly improving the microclimate, and hence energy consumption, for the property.

Protection of these trees during excavation and construction should be a priority, and guidelines for that protection can be provided.
