March 11, 2020  
 Tree Assessment Report  
 706 South Main Street, Hailey

Alpine Tree Service has been asked by ARCH Community Housing Trust to assess the condition of the trees on a parcel of property located at 706 South Main Street in Hailey. The site was formerly occupied by a hospital and senior care facility. The site is vacant with the exception of a number of trees. The purpose of this report is to evaluate those trees subject to a redevelopment proposal by ARCH.

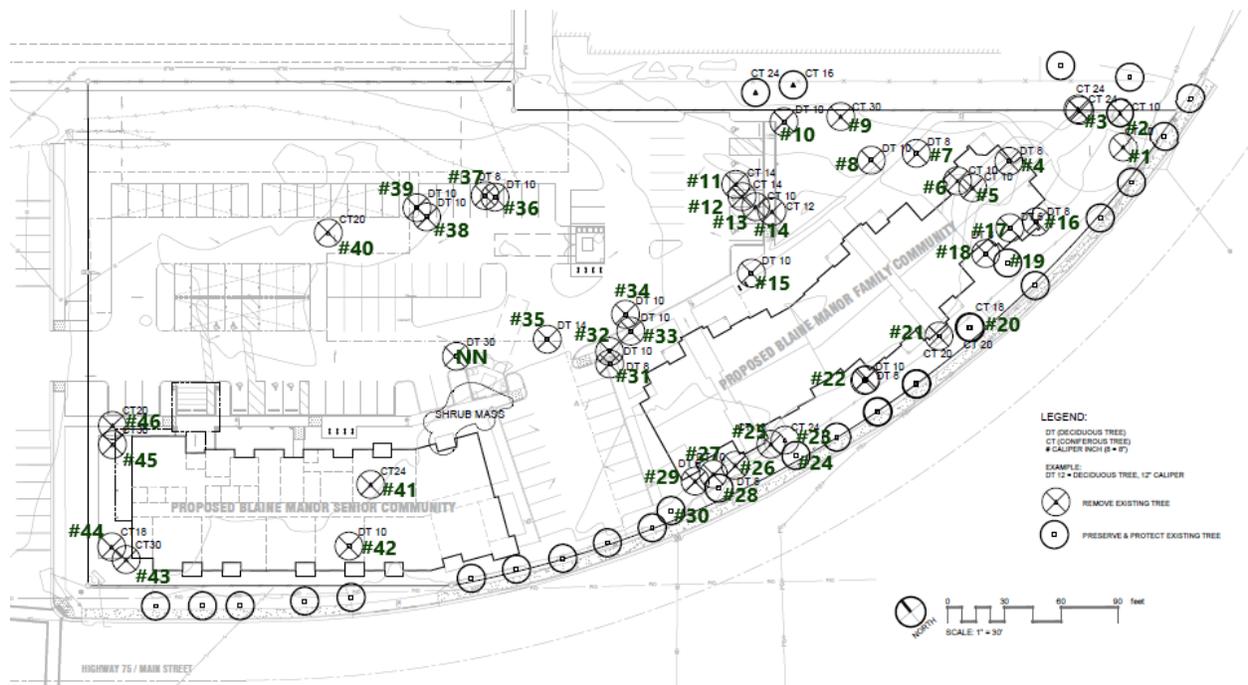
A plan has been generated (below) that numbers the trees on the property generally from south to north. Additionally, the surveyors have shown the location of the trees with deciduous and coniferous trees called out and the size of those trees shown. Field inspection of the trees shows that most of the trees sizes shown are accurate, but that some seem to have been inaccurately recorded. The discussion of the trees, below, shows their species and size.
